Reprocessing of PPE Garments for re-use by clinical staff by Vaporised Hydrogen Peroxide

Reprocessing of PPE Garments for re-use by clinical staff – Vaporised Hydrogen Peroxide method

REPORT

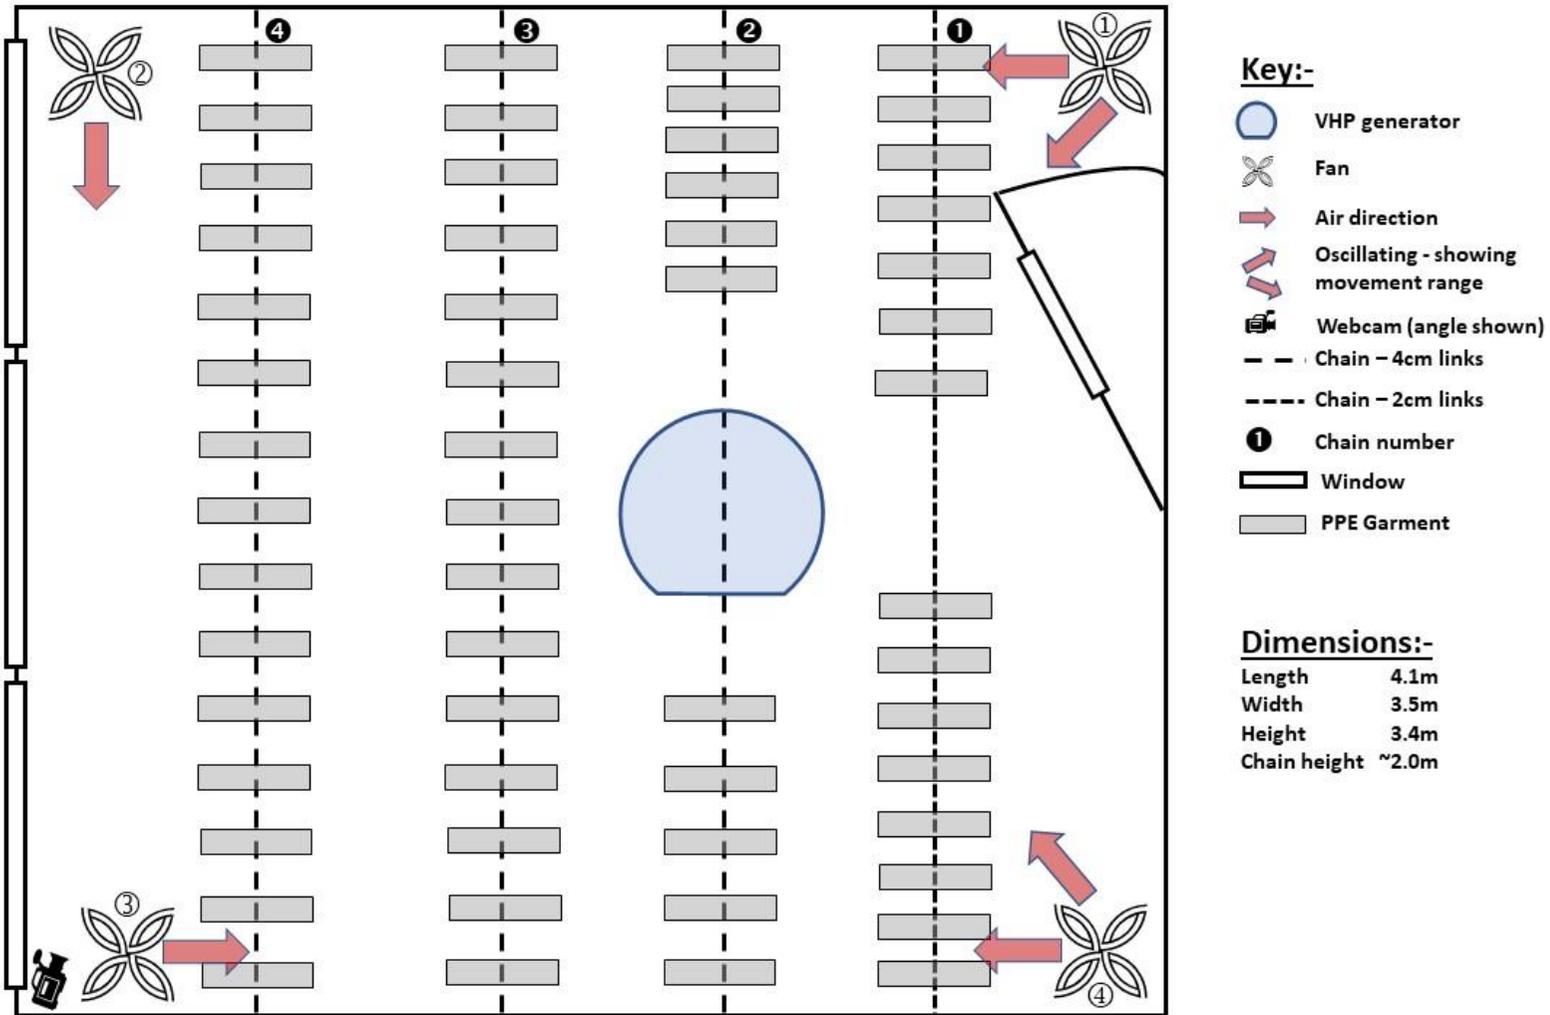
An office was selected to be converted for use as the reprocessing chamber, accessed from a quiet corridor and in the area managed by Sterile Services dept, also responsible for PPE garment washing/drying. The space measured 4.1m long (door to windows), 3.5m wide and 3.4m high.

The space was cleared of all furniture and fittings and new vinyl floor covering placed over the existing covering, sealed all round with waterproof duct tape. Opening windows frames were made of powder coated aluminium, existing wall and ceiling finishes were washable paint, the door with inset window was of varnished wood and included key and number-pad locks. Electrical fittings in trunking and light fittings were left in place, ceiling-mounted smoke sensor was electrically isolated and physically covered. There was no false ceiling or ceiling tiles. All surfaces were cleaned of visible dust and debris, including tops of windows and light fittings. All holes in the walls were sealed with duct tape; there were no channels to adjacent offices.

Chains (galvanised steel) were suspended width-wise 2m above the floor, to secure wall fixings, 4 rows in total equally spaced along the length of the space. Rows 2-4 had links approx. 4cm long; row 1 had shorter links approx. 2cm long.

Figure 1 – Room layout for reprocessing chamber, Run 1

See **Figure 1** for details of room layout.

See **Figure 1** above and **Figure 2** below for layout of this equipment.

1. VHP generator was sited centrally in the chamber – orientated as in Figure 1 (during operation VHP is emitted radially through 270° but no gas emits from the flat side)
2. Garments were hung from coat hangers hooked through the chain loops at the following spacing:-
 - a. Row 1 (small chain links) 8-9 links = approx. 15cm – 15 garments in total (8+7) separated with a gap
 - b. Row 2 (large chain links) :
 - i. Behind generator (lower diag) 6-7 links = approx. 20cm – 5 garments
 - ii. In front of generator (upper diag) 4 links = approx. 10cm – 6 garments
 - c. Row 3 (large chain links) 6-7 links = approx. 20cm – 15 garments
 - d. Row 3 (large chain links) 6-7 links = approx. 20cm – 15 garments

5. Observers stood inside the room near the door; garment movement at the far end was observed via the webcam and laptop.
6. Since insufficient movement was observed fans were sited one by one until movement was adequate, located as in Figure 1. Fans 1 & 4 placed on the floor were set to oscillate, fans 2 & 3 mounted on stands were set for a fixed direction.

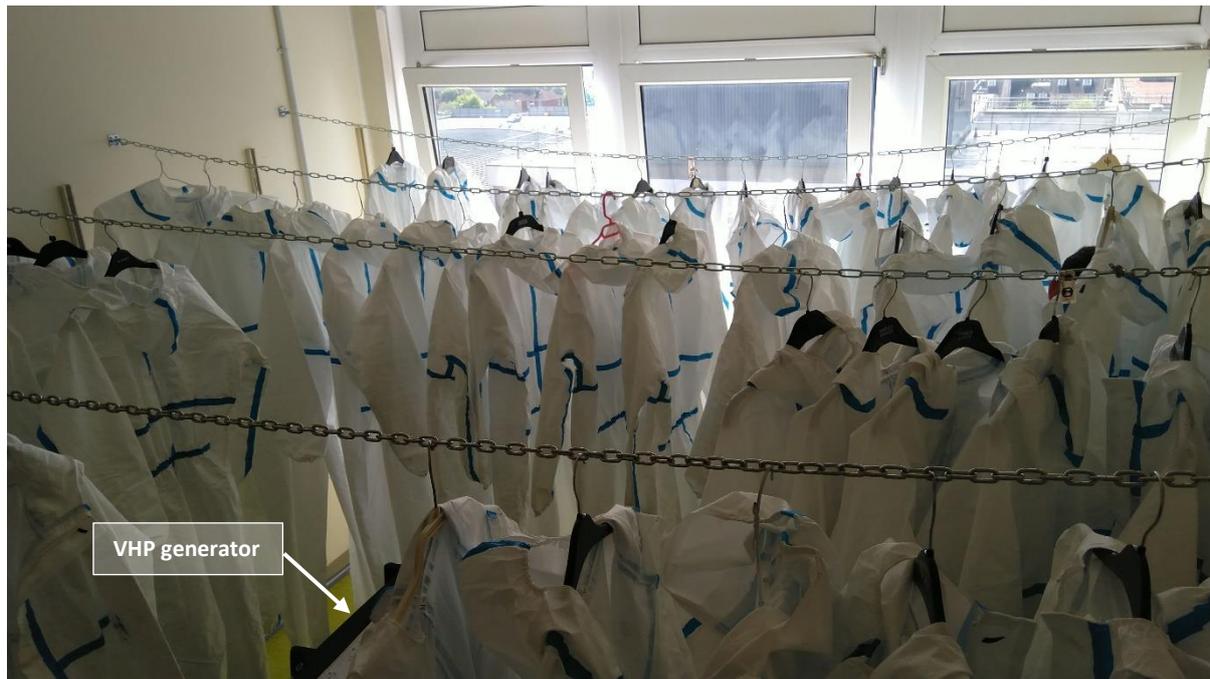
Figure 2 – over-head view of garments in final loading pattern, taken from door (Study 1 & 2 Run 1)

Movement was demonstrated in line with protocol acceptance criteria. Video was captured and saved. Loading pattern was recorded on paper

Figure 2 shows an image of the fully loaded chamber for Study 1 and Study 2 Run 1

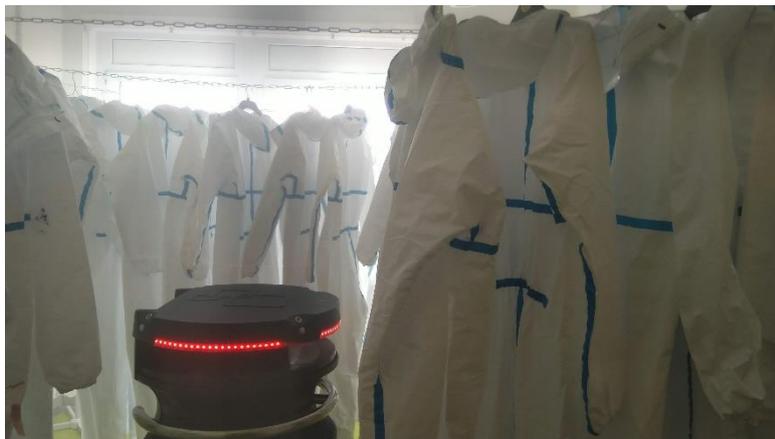
Figure 3 - VHP generator in operation

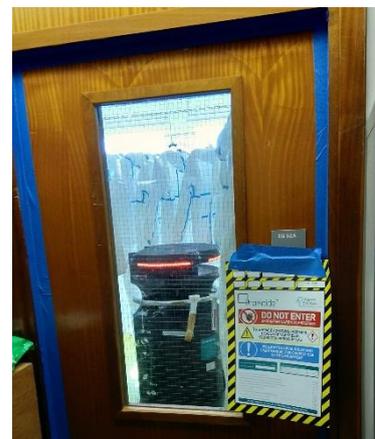
Figure 4 – Room locked & sealed with safety signage

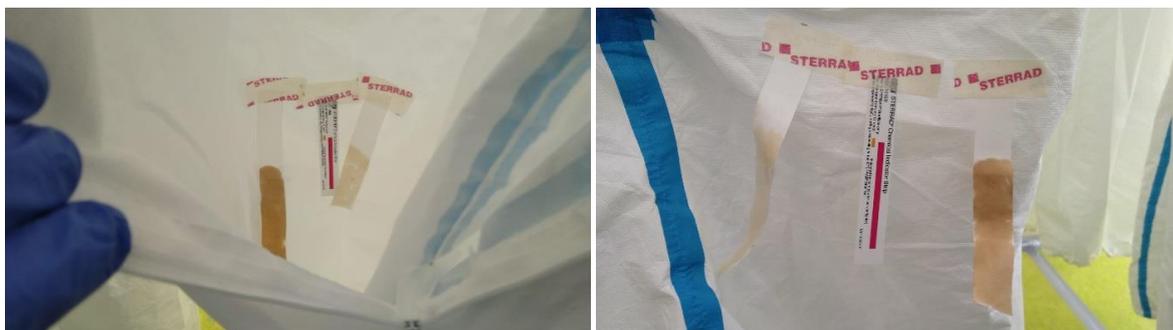
Figure 5 – Chemical indicators pre-exposure, showing location inside garment (left) and outside (right)

- i. Outer-surfaces facing towards or away from the generator (see **Figure 5 right**)
 - ii. Inside garments (see **Figure 5 left**)
 - iii. Different positions on the garment

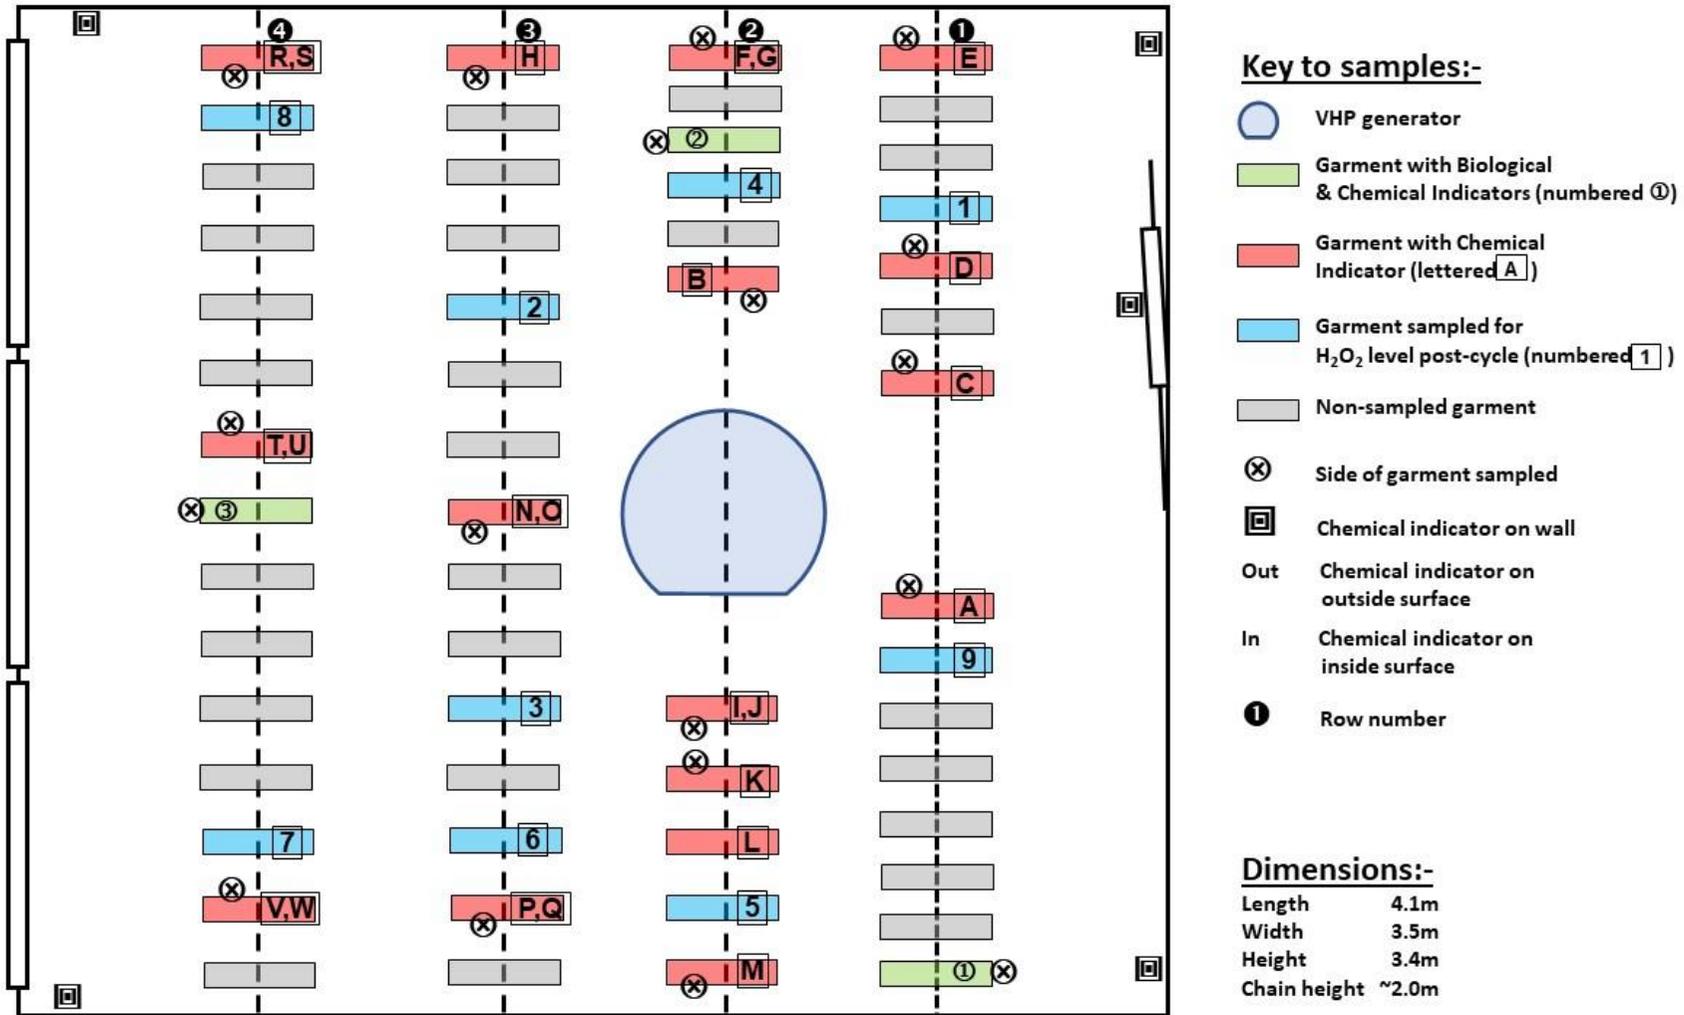
Figure 6 – Sample layout, Study 2 Run 1

11. The arrangement of garments with biological and chemical indicators and gas-tested samples is shown in **Figure 6** – Sample Layout

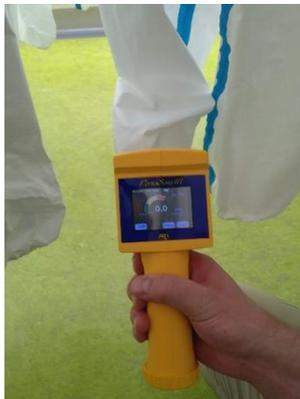
For garments 6-9 only the inside lower leg was tested since shown in previous samples to be indicative of worst case – see **Figure 7**.

Figure 7 – sampling garment H₂O₂ levels post-cycle

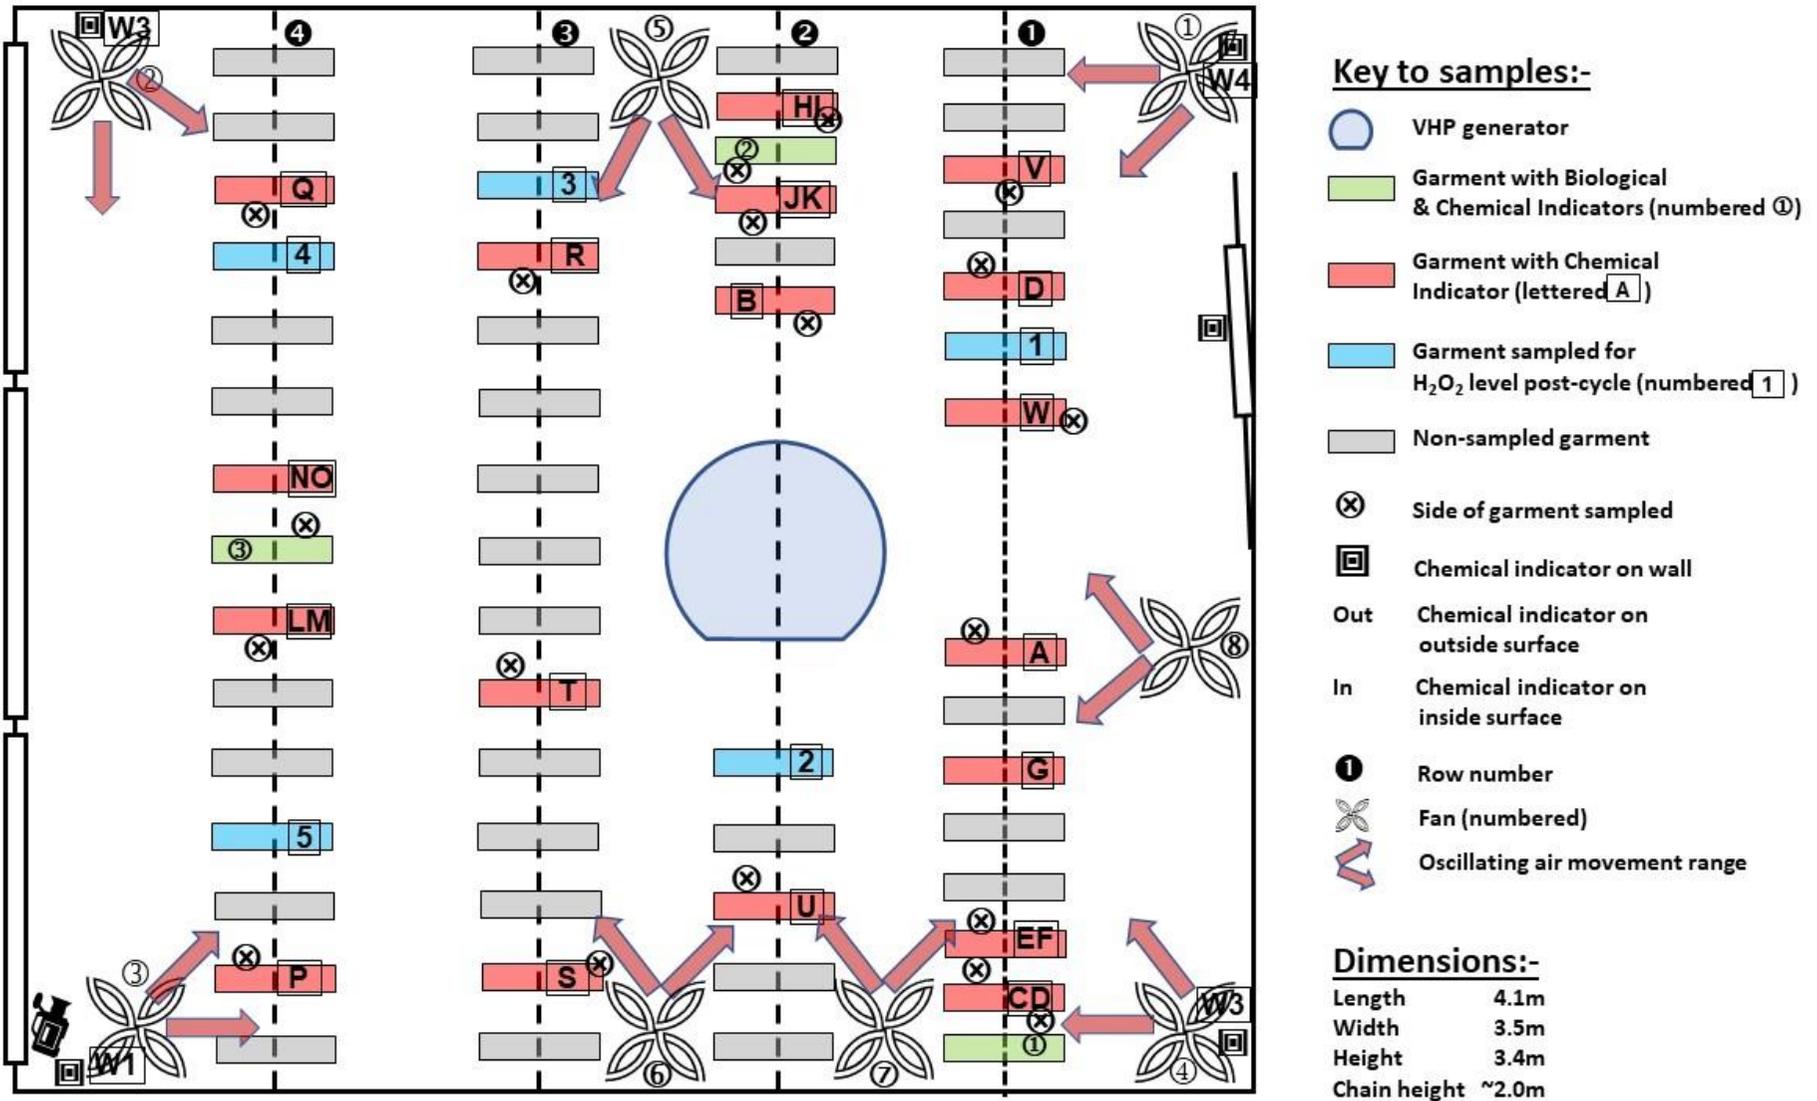
Figure 8 – Sample and Fan layout, Study 2 Run 2

- e. Chemical indicators
 - i. Only the commercially available Sterrad indicators were used, as these had been demonstrated effective in Run 1.
 - ii. New indicator locations were used, although similar to Run 1
- f. Run took place on a working day as no inadvertent exposure had been detected for Run 1

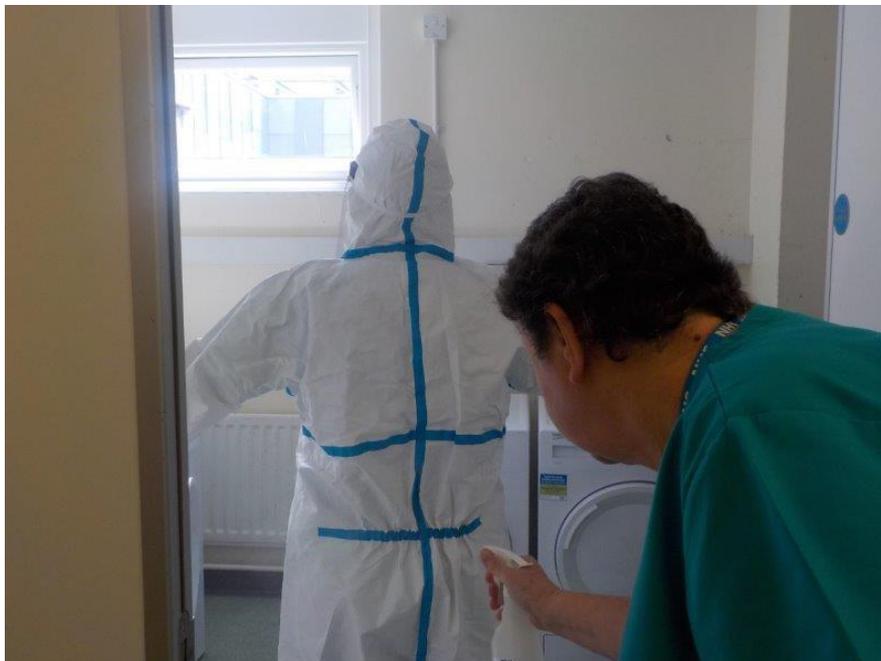
- A staff member wearing cotton scrubs dons the test garment,
- Whilst being worn the garment is liberally sprayed with clean water from a handheld trigger sprayer, See **Figure 9** below.
- The garment is carefully removed and scrubs examined,
- Darker (ie damp/wet) areas indicate permeability failure

Figure 9: Post-cycle garment permeability testing

Since it is unfeasible to test permeability to the original garment standards (EN 14126:2003), integrity against fluid ingress was then tested with a UHS-derived physical test:-
